LMP Module and Controller Update Instructions from Fresco™ Touchscreen

Summary

Fresco Touchscreens are capable of updating the LMP Panels (LMP Module and LMP Controller) firmware from the RDM tab. The methodology used is very similar to the existing methodology used to update the Fresco RB and Fresco AVIs from the FCN tab.

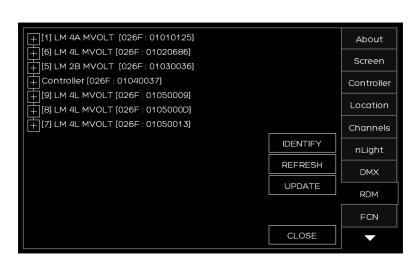
Figure 01

+ [1] LM 4A MVOLT [026F: 01010125] About + [6] LM 4L MVOLT [026F : 01020686] Screen + [5] LM 2B MVOLT [026F: 01030036] + Controller [026F : 01040037] Controller + [9] LM 4L MVOLT [026F : 01050009] Location + [8] LM 4L MVOLT [026F : 0105000D] + [7] LM 4L MVOLT [026F : 01050013] Channels IDENTIFY nLight REFRESH DMX UPDATE RDM FCN CLOSE

- Update the Fresco Touchscreen and Fresco Studio firmware and software to the latest version.
 (Fresco firmware of 201.31.2 or greater is required).
- 2. Connect the LMP Panel to Fresco via DMX like normal.
- 3. Go to the RDM Tab. It should auto discover the connected LMP modules and controllers (Figure 01).
- 4. If the LMP Controller is on firmware version FR07V129 or earlier, you must first update the LMP Controller and then once the LMP Controller is on firmware FR07V130 or later you can update the LMP Modules.
- 5. Select the LMP controller or LMP module to update and then hit the update button (Figure 02).
- 6. Next, select the firmware file to update to (Figure 03).
